FIRE RESISTANCE TEST REPORT

No. Pr-14-2.072-En

**Fire Resistant Loft Ladder KYLF
KYLF01, KYLF09**

Sponsor: **KEYLITE ROOF WINDOWS Ltd.**
Dellyrolan Industrial Estate, Sandholes Road
Cookstown, Co. Tyrone
BT80 9LU
United Kingdom

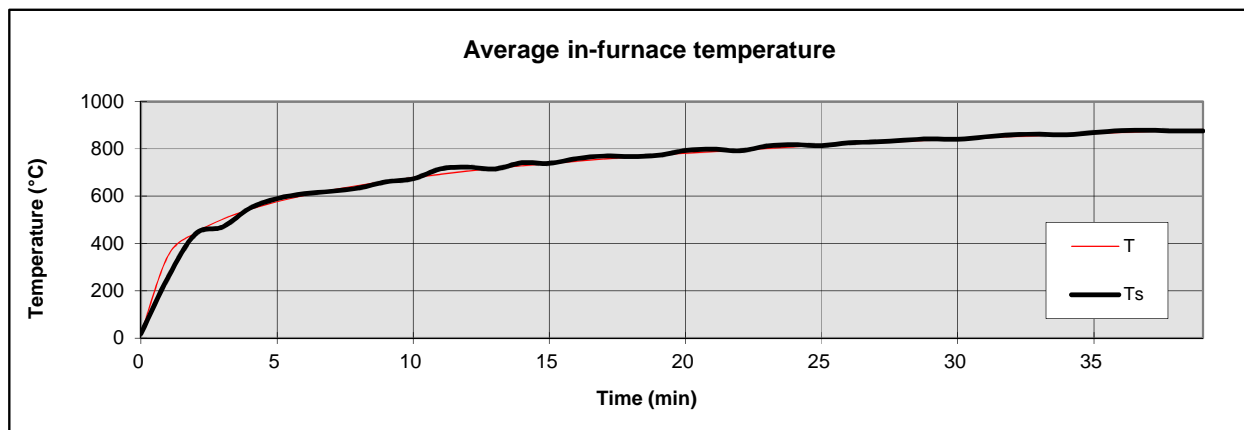
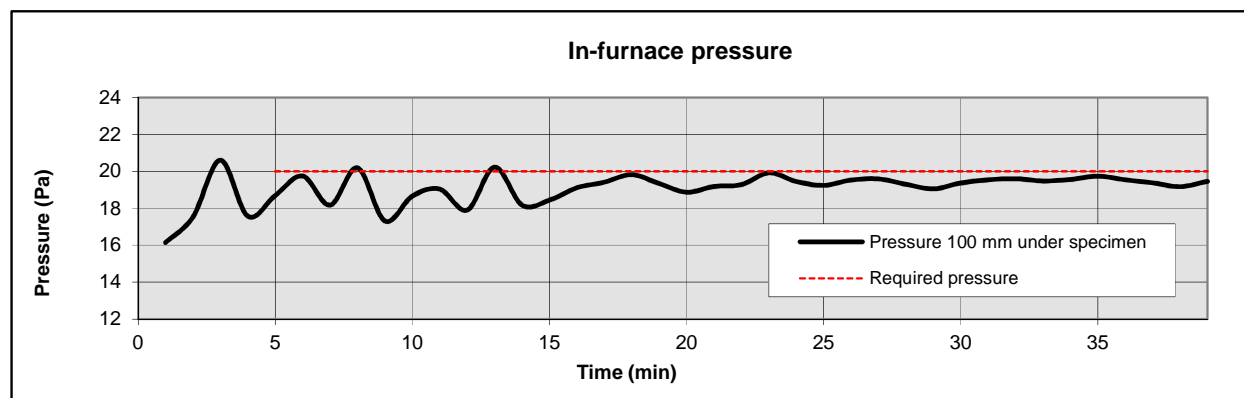
In-furnace temperature and pressure, ambient temperature

Temperatures recorded at minute intervals. In the table, they figure at 5 minute intervals.

The in-furnace temperatures met the requirements of [2]. Time relations to the measured temperatures are specified in Annex 2.

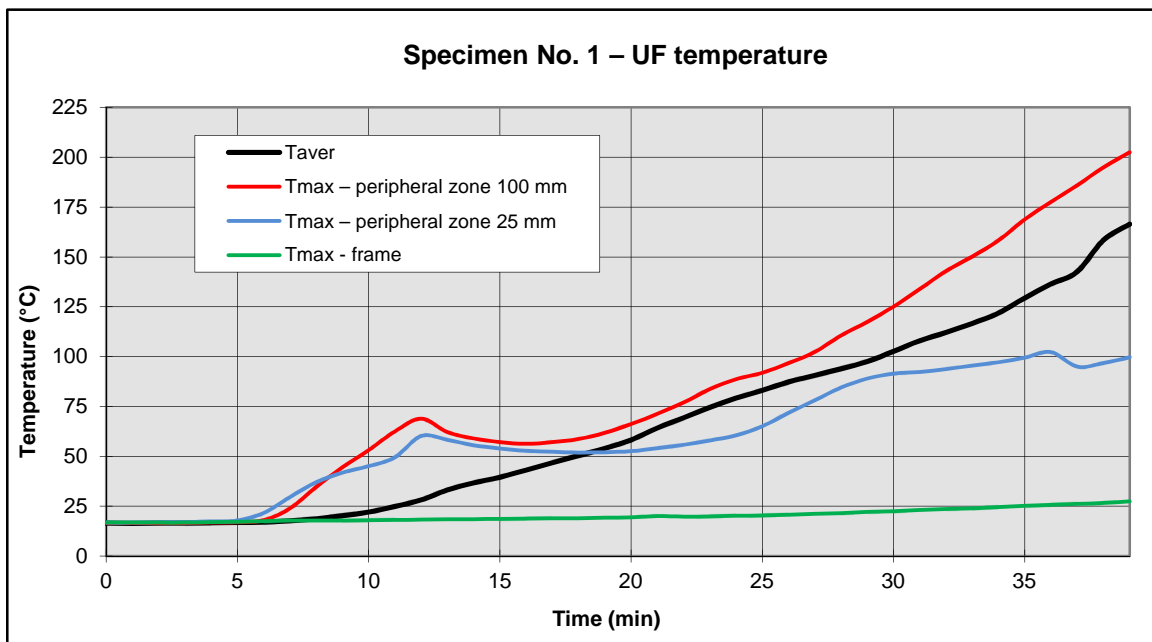
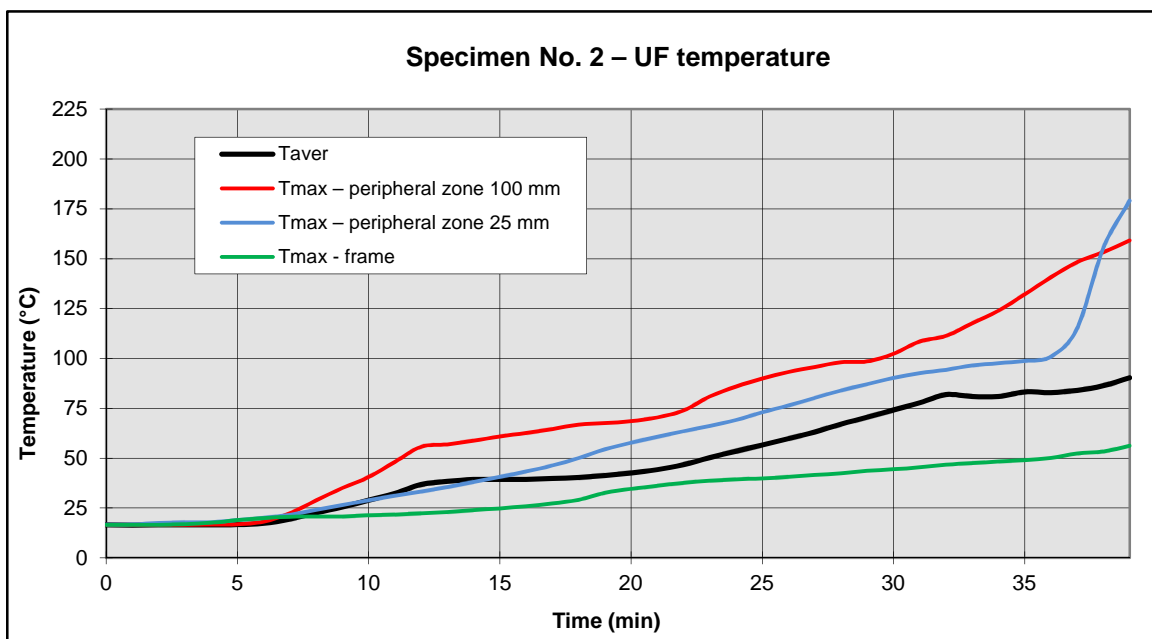
Specimen No. 1 – UF specimen temperature (°C)

Specimen No. 2 – UF specimen temperature (°C)

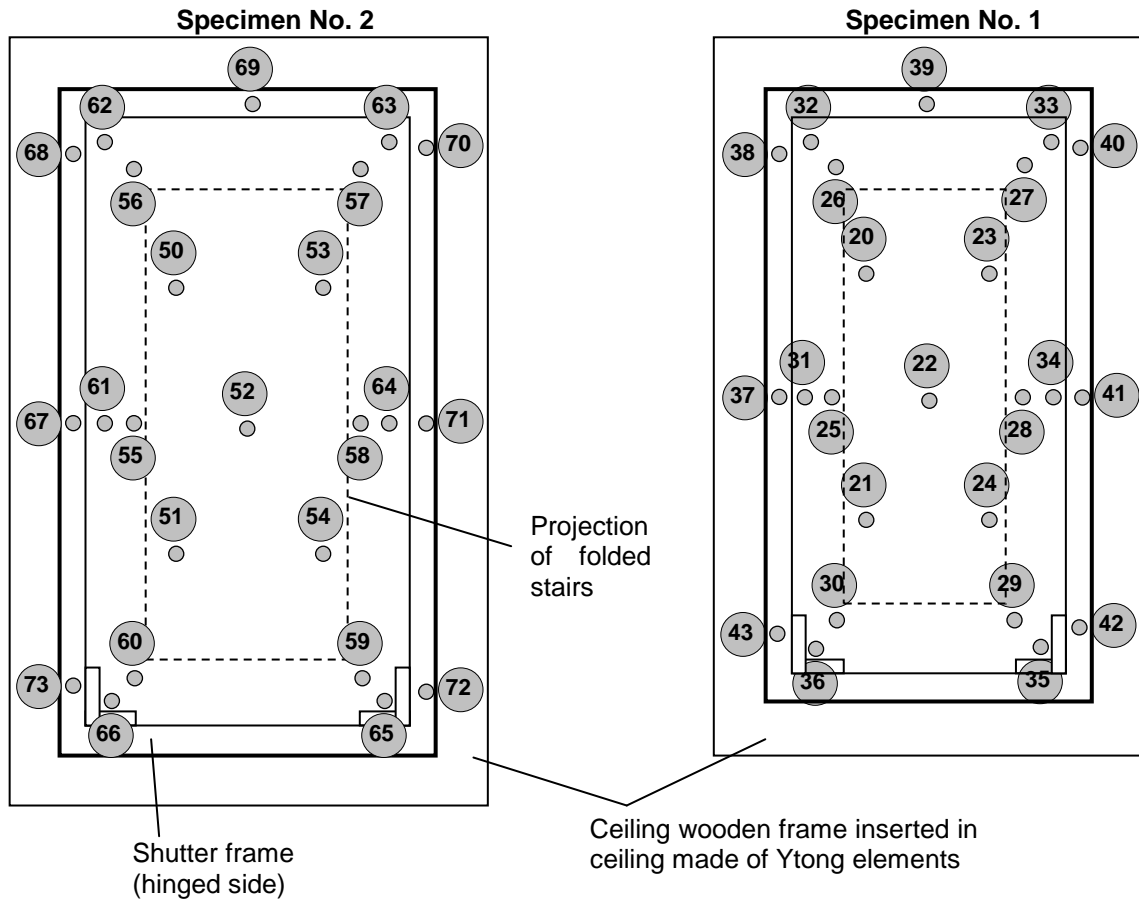
Layout of TCs on specimen UF

Specimen No. 1

- 20 ÷ 24 - average and maximum UF temperature
- 25 ÷ 30 - maximum UF temperature - peripheral zone 100 mm
- 31 ÷ 36 - maximum UF temperature - peripheral zone 25 mm
- 37 ÷ 43 - maximum UF temperature - shutter frame

Specimen No. 2

- 50 ÷ 54 - average and maximum UF temperature
- 55 ÷ 60 - maximum UF temperature - peripheral zone 100 mm
- 61 ÷ 66 - maximum UF temperature - peripheral zone 25 mm
- 67 ÷ 73 - maximum UF temperature - shutter frame

The specimen unexposed surface temperatures were measured using K-type TCs and recorded at minute intervals. The measuring joints of TCs were soldered to the centre of a copper disc of 12 mm in diameter and of 0.2 in thickness and they were covered with a plate of 30 x 30 mm in size and of 2 mm in thickness (see [2] art. 4.5.1.2). TCs were fixed to the specimen surface as per [1] art. 9.1.2.

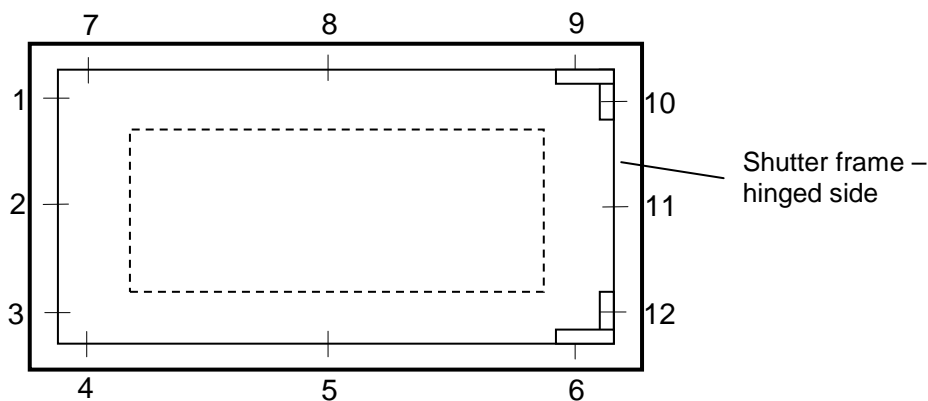
Measurement of width of primary gaps

Gap	Position											
	1	2	3	4	5	6	7	8	9	10	11	12
a	4,3	4,3	4,1	3,8	3,9	3,6	3,8	4,6	3,8	2,1	2,0	2,2
b	4,0	4,0	3,8	3,4	3,4	3,2	3,9	4,2	3,8	1,2	1,5	1,3

Gap	Position											
	1	2	3	4	5	6	7	8	9	10	11	12
a	3,9	3,2	2,8	5,3	5,1	2,9	3,8	5,0	5,9	2,1	2,5	2,9
b	2,9	2,7	2,6	5,4	5,9	3,9	5,2	5,1	4,6	2,5	2,0	1,0

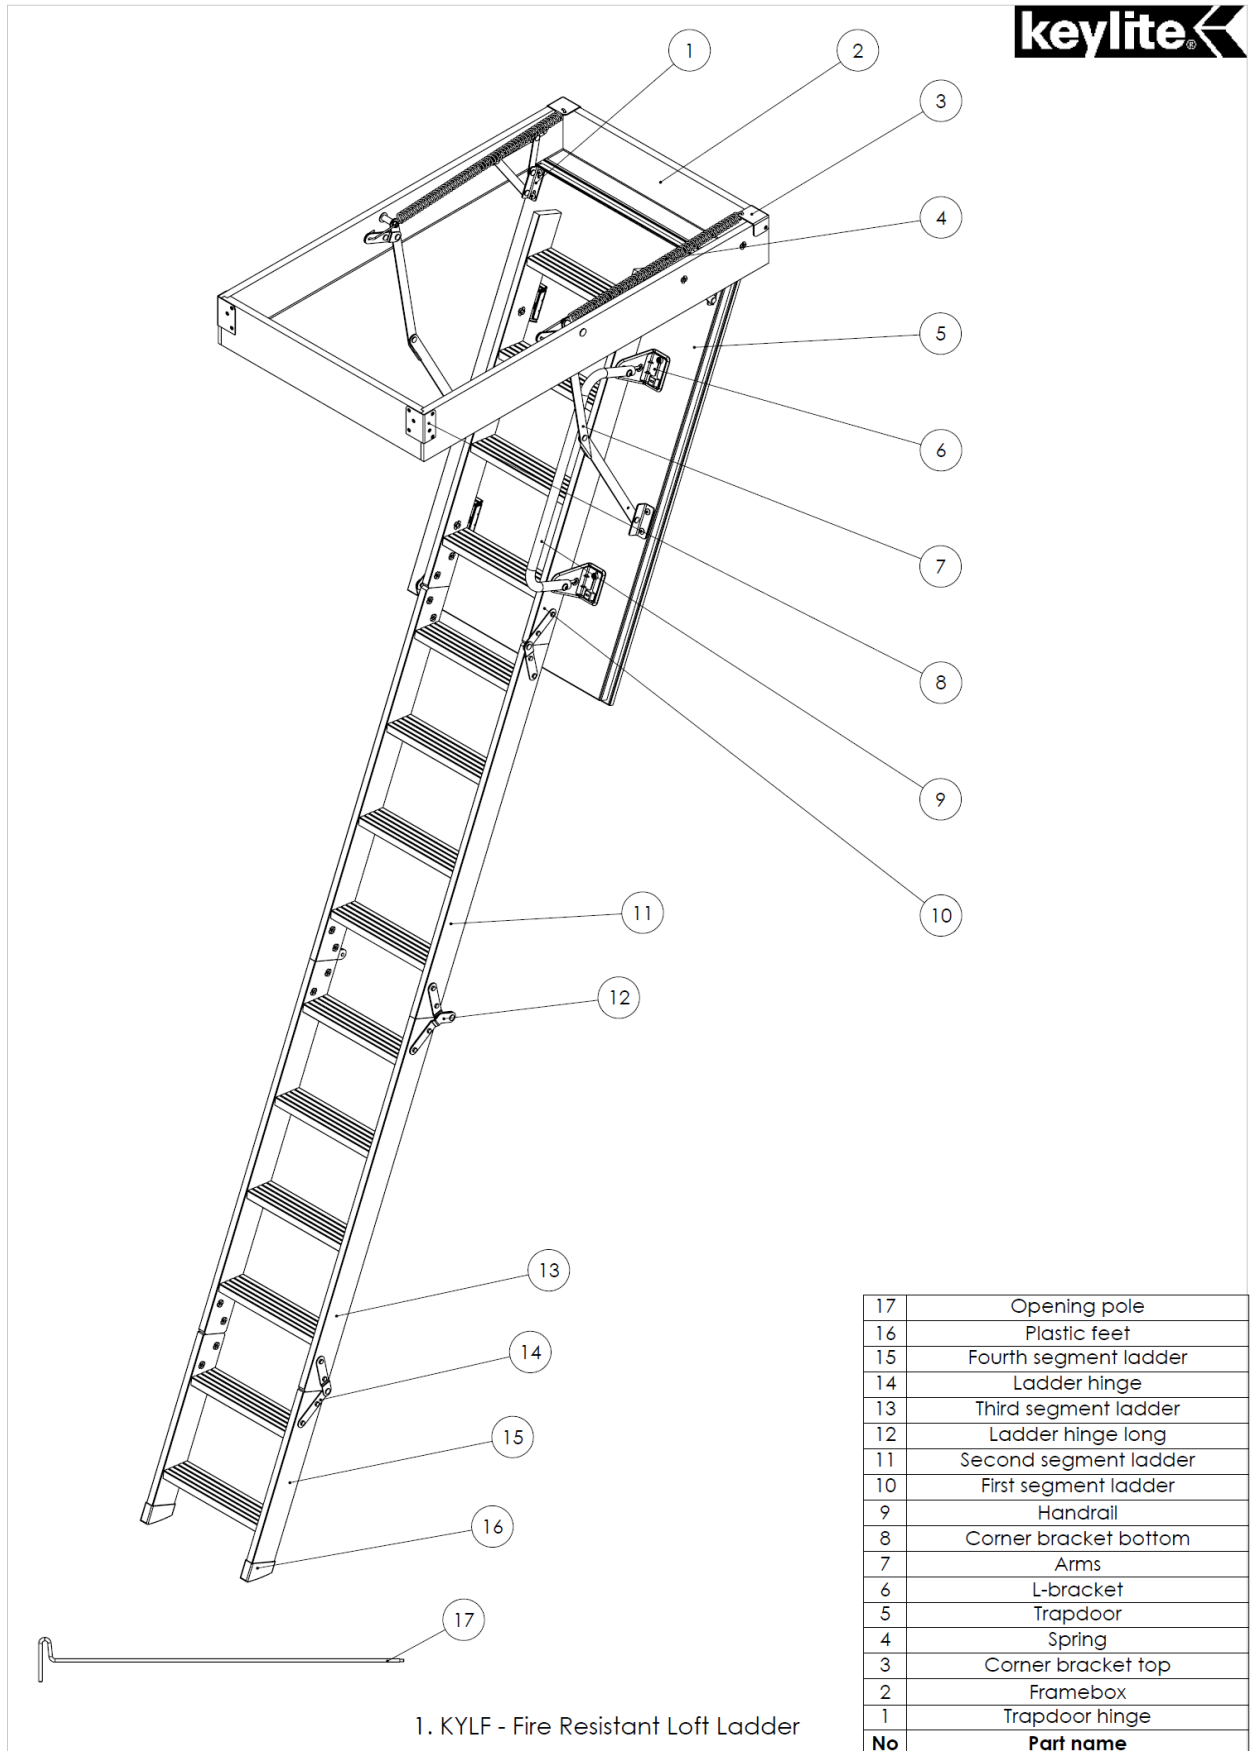
1. KYLF - Fire Resistant Loft Ladder

17	Opening pole
16	Plastic feet
15	Fourth segment ladder
14	Ladder hinge
13	Third segment ladder
12	Ladder hinge long
11	Second segment ladder
10	First segment ladder
9	Handrail
8	Corner bracket bottom
7	Arms
6	L-bracket
5	Trapdoor
4	Spring
3	Corner bracket top
2	Framebox
1	Trapdoor hinge
No	Part name

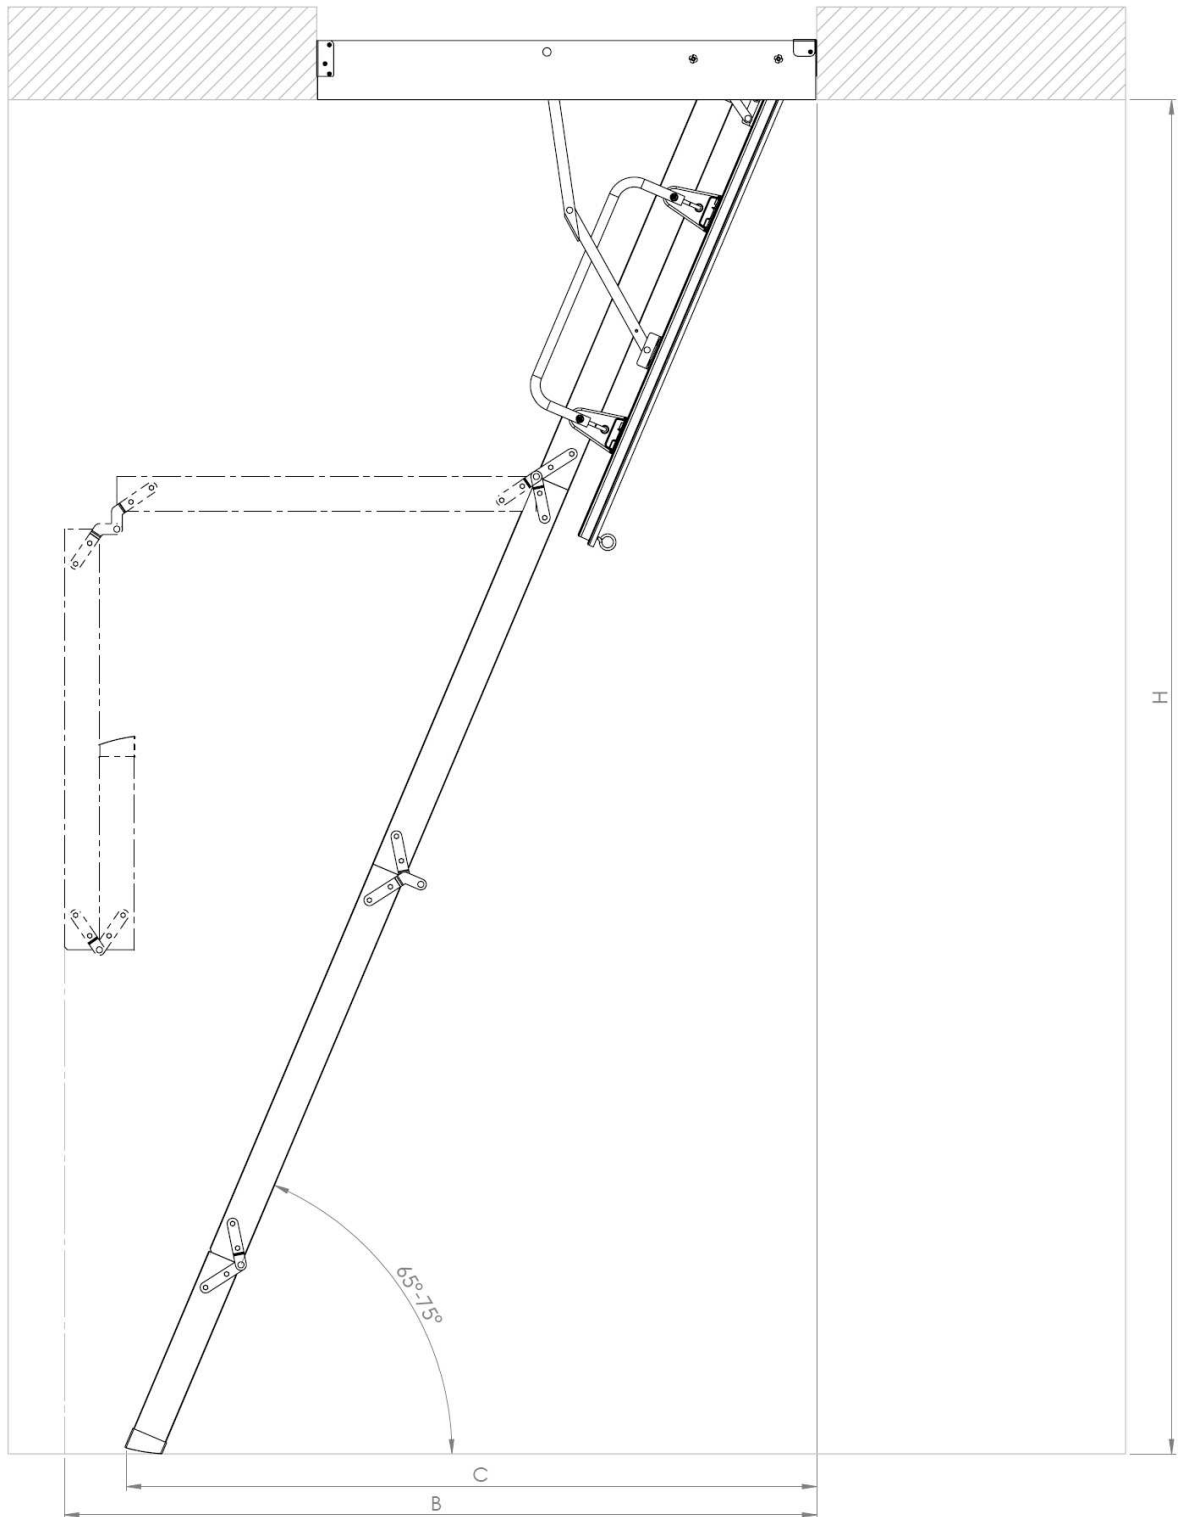
3. Space occupied by Loft Ladder

KYLF01	KYLF02	KYLF03	KYLF04	KYLF05	KYLF06	KYLF07	KYLF08	KYLF09
Room height (m)	H	2,6-2,8	2,6-2,8	3,0-3,2	2,6-2,8	2,6-2,8	3,0-3,2	2,6-2,8	2,6-2,8	3,0-3,2
Number of ladder segments [units]	-	4	3	4	4	3	4	4	3	4
Swing space (mm)	B	1300-1590	1565-1675	1605-1715	1300-1590	1565-1675	1605-1715	1300-1590	1565-1675	1605-1715
Distance after ladder unfolding (mm)	C	1025-1385	1025-1385	1145-1575	1025-1385	1025-1385	1145-1575	1025-1385	1025-1385	1145-1575

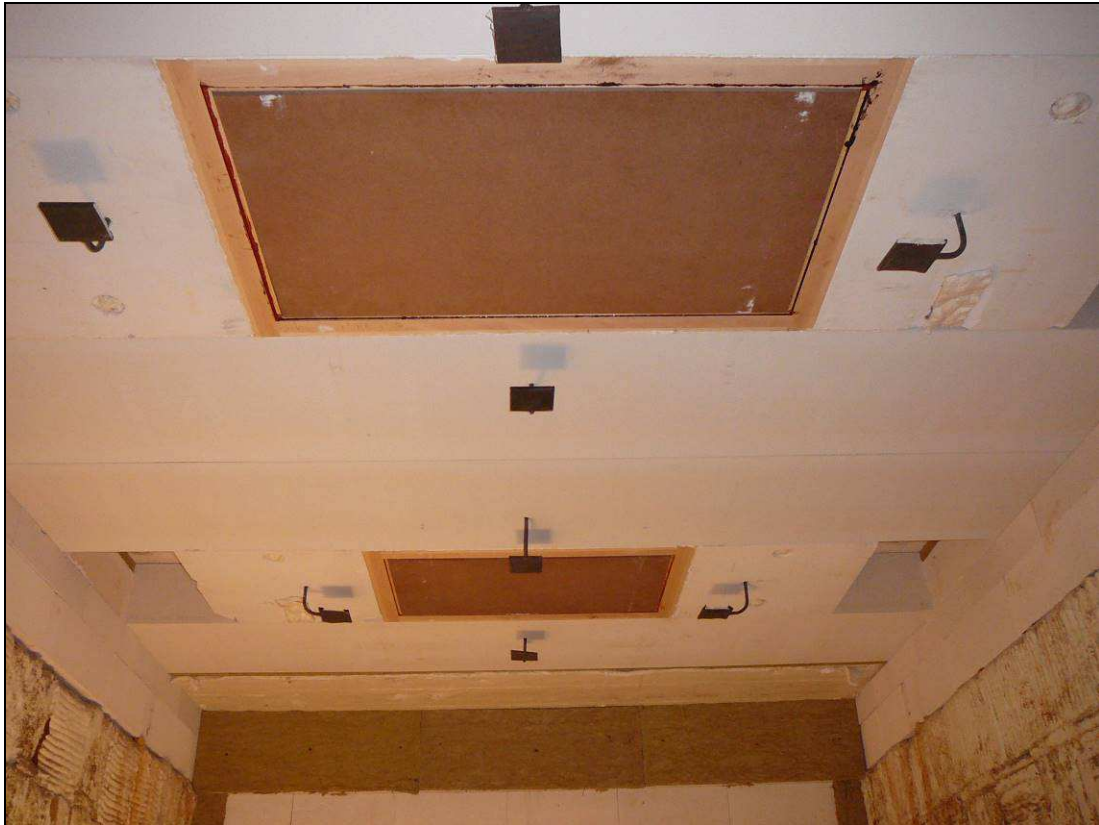
EF prior to test

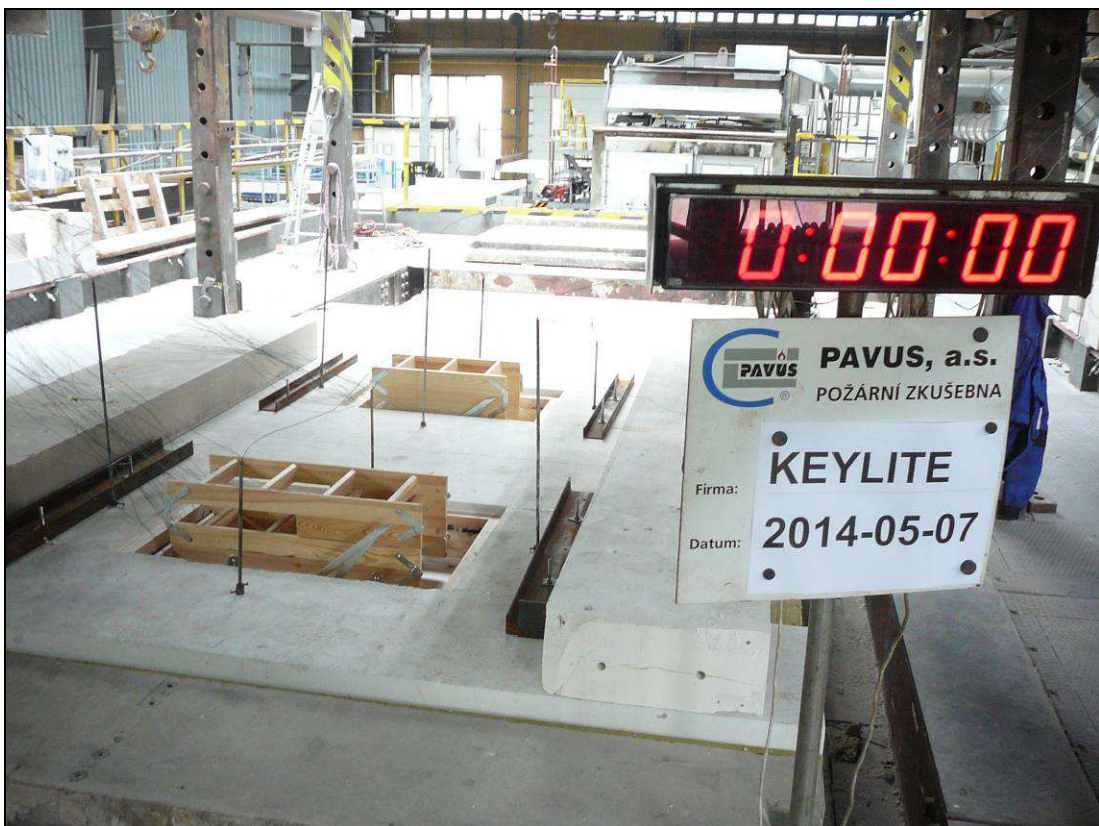
UF prior to test

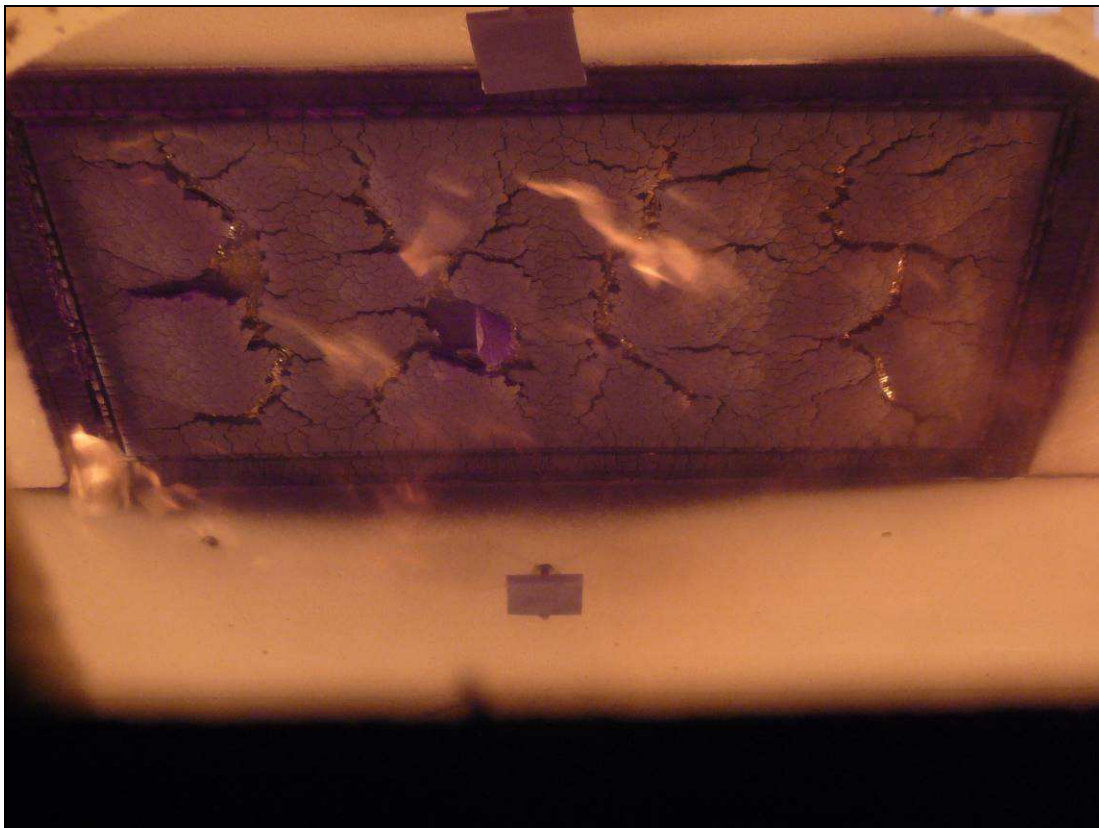
EF of specimen No. 2 – 14th test minute

| 14. | EF – wide cracks in surface, local exposition of second composition layer |

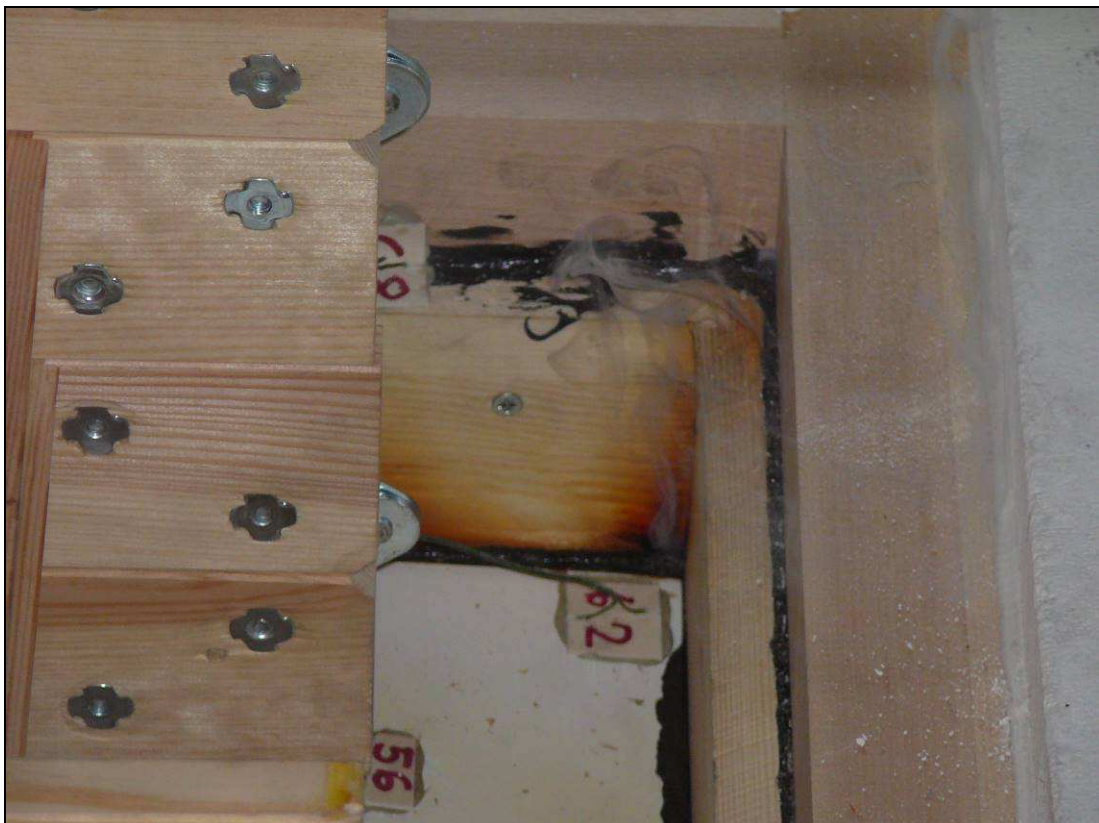
Specimen No. 2 – reaction of intumescent tape in gap – 20th test minute

| 30. | UF – extrusion of intumescent tape through the shutter peripheral gap

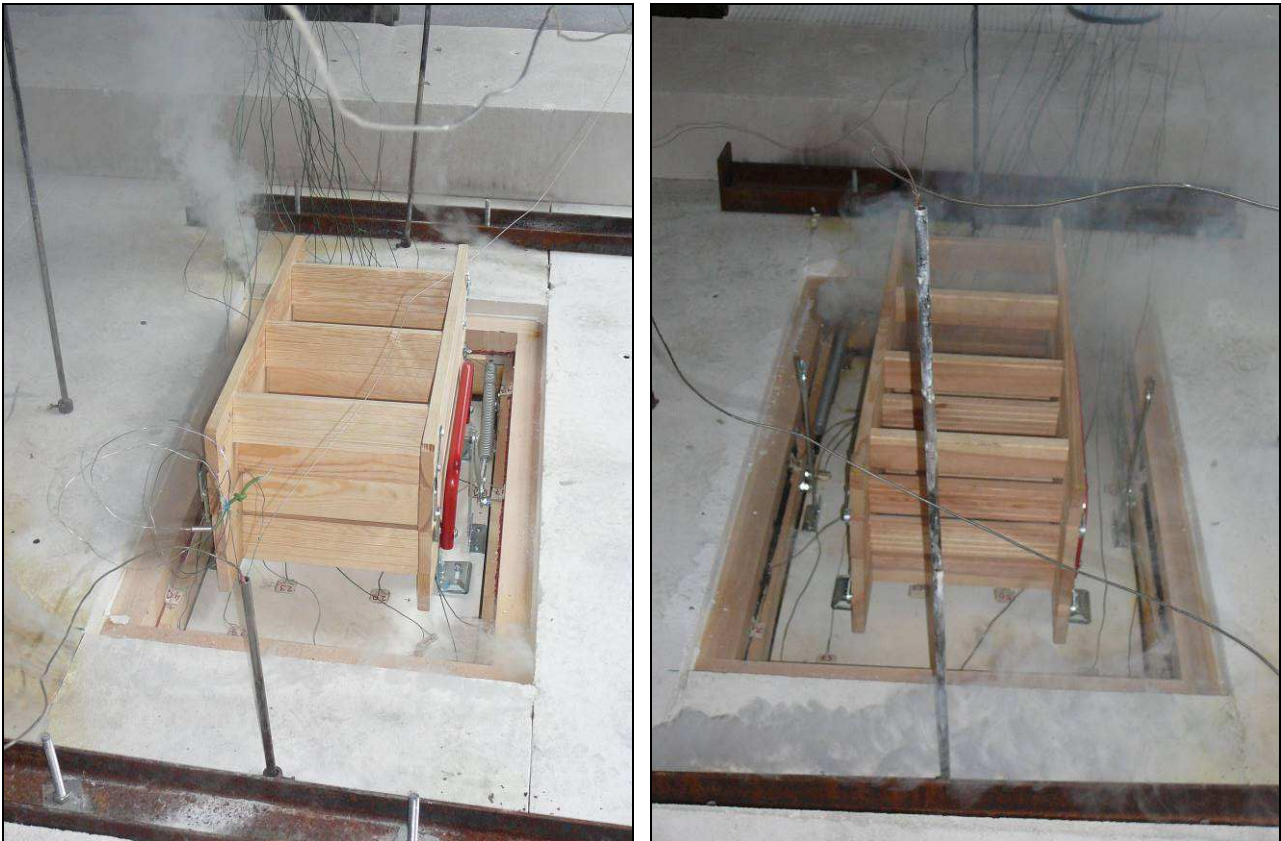
Specimen No. 1 and 2 – 31st test minute

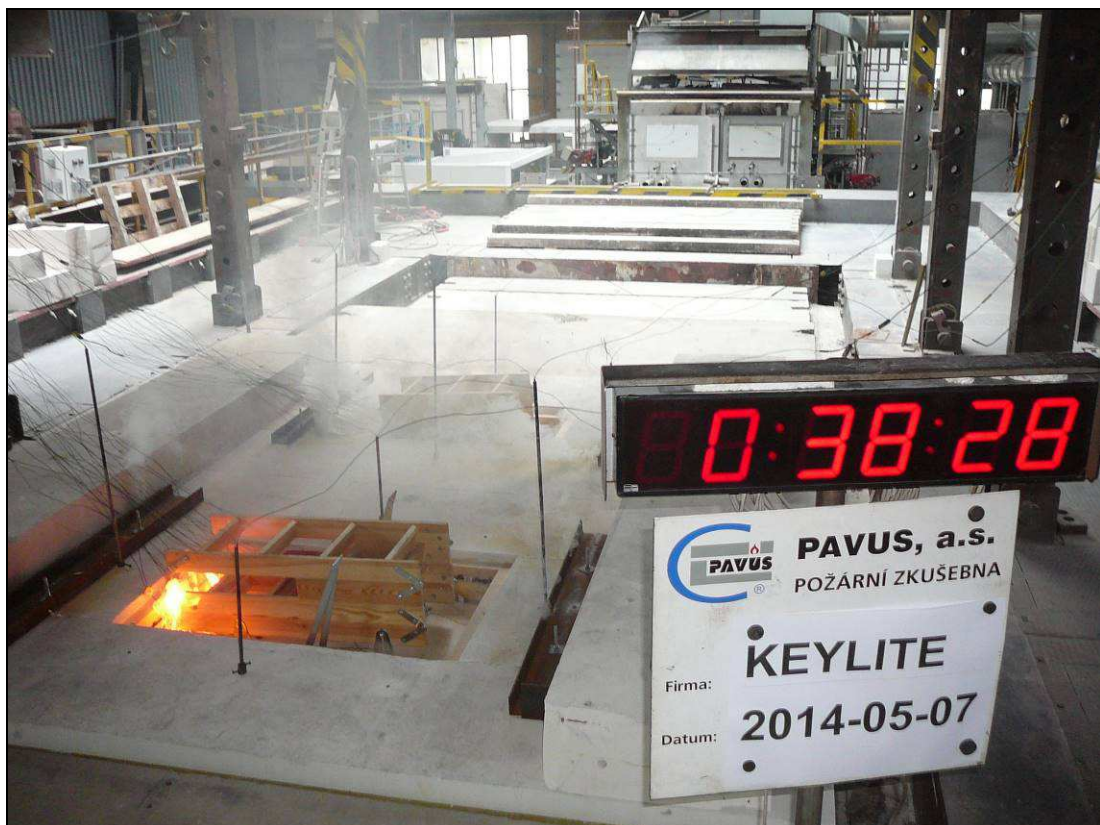
End of test, integrity failure of specimen No. 2 – 39th test minute

| 39. | UF – sustained flaming at the hinged shutter side – integrity failure |
